# Manhole Inspection Summary

Manhole # S69S\_\_011MH

Insp Date: **4/1/08 2:33 PM**

**Location** Address: **1700 Manor Ave.**

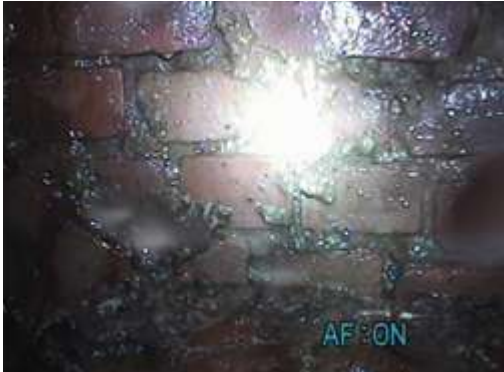
Defect 6

Wall infiltration

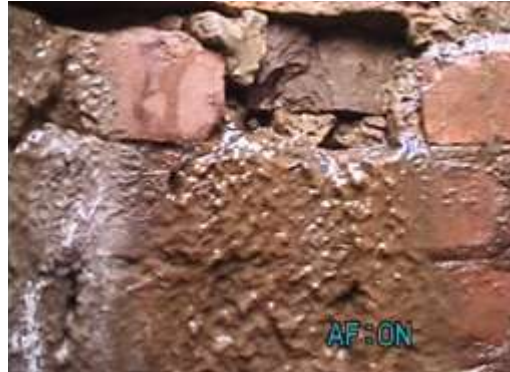
Defect 5

Missing brick and mortar as well as infiltration through cracks. This is just under the frame above O12

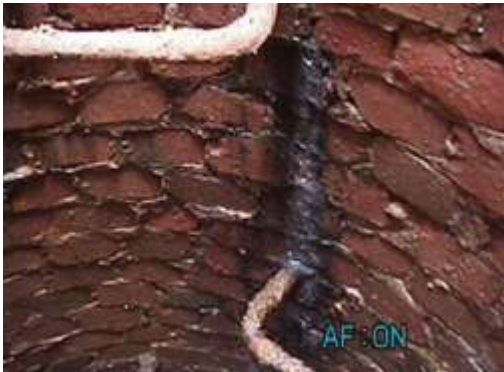
Defect 4

Dripper in barrel wall under step.

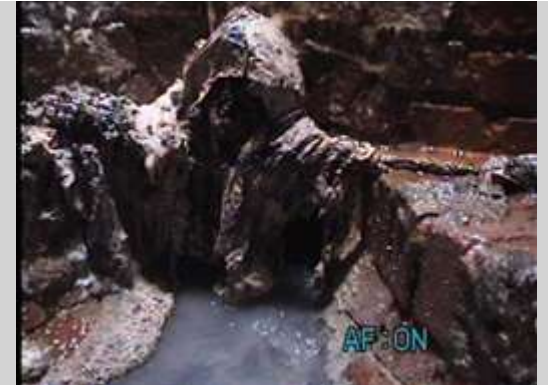
12 O'Clock Outflow

Pipe Height: **10.8** (in.) Rod and Bar (Angled)  
Pipe Material: **Clay** ☐ Pipe Lined  
Invert Depth: **15.33** (ft.) Flow Characteristics: **Fast**  
Deposits: ☐ None ☐ Mud ☐ Sludge ☐ Debris ☒ Grease  
Silt Depth: **0.5** (in.) Deposits Extent: **Medium**  
Infiltration: **None** Pipe Seal Cond: **Sound**
